PLAY AREA SAFETY INSPECTION REPORT

Compton Parish Council

17 June 2015

Site Owner : **Compton Parish Council**
Site Name : Compton Parish Council - Spiceall Recreation Ground
Date of Inspection : 17 June 2015
Inspected by : Bill Slater

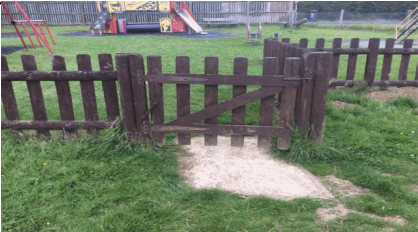
Item	Type	Comments, action or control required	Risk Level	Risk Score†
Facilities				
Litter Bin Risk Score : 3 Risk Level : Very Low	Bins	Satisfactory  		
Horticulture				
Planting Risk Score : 4 Risk Level : Low	Borders	Satisfactory  		
Perimeter				
Fencing Risk Score : 3 Risk Level : Very Low	Fencing	Finding : Fencing - Panel damaged   Finding Date : 17/06/2015 Notes : Fence damaged in multiple areas and loose in ground. Task : Repair	Low	5
Gate Risk Score : 3 Risk Level : Very Low	Entrance	Satisfactory

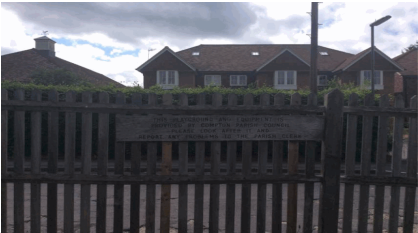
Site				
Sign - No Dogs Risk Score : 2 Risk Level : Very Low	Signage	Satisfactory		
Sign - Ownership Risk Score : 2 Risk Level : Very Low	Signage	Satisfactory

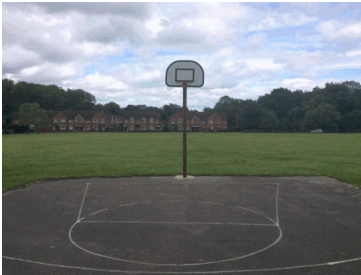
Basketball Post

Risk Level : Medium

Risk Score : 8

The item fails to meet the requirement of the relevant standard.

Comments, action or control required		Risk Level	Risk Score ‡
Equipment			
Finding :	A warning notice should be fitted to all sports related equipment with the words "Do not climb on the framework or nets", "Do not hang on the ring" (if provided), "Do not wear rings or other jewellery as these can get caught and cause injury"	Very Low	3
Task :	Fit warning notice		
Surfacing - Tarmac		No remedial maintenance work is required at this time.	
The overall risk for this item at the time of inspection: ‡ For Risk Score see Report Notes		Medium	8

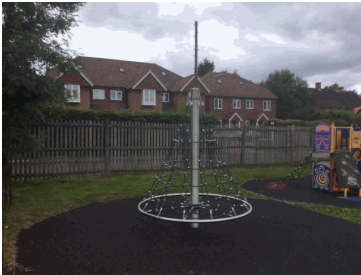
Climber - Rotor Web

Risk Level : Low

Risk Score : 6

Comments, action or control required	Risk Level	Risk Score ‡
Equipment No remedial maintenance work is required at this time.		
Surfacing - Wet Pour		
Finding : Surface - Needs Repair	Low	5
Finding Date : 17/06/2015		
Notes : Sinking in areas.		
Task : Repair surface		
The overall risk for this item at the time of inspection: ‡ For Risk Score see Report Notes	Low	6

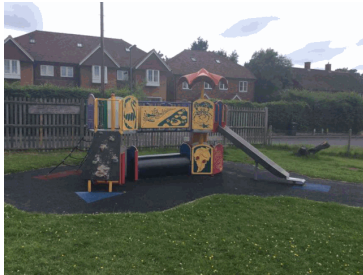
Multiplay - Toddler

Risk Level : Low

Risk Score : 6

Comments, action or control required	Risk Level	Risk Score ‡
Equipment No remedial maintenance work is required at this time.		
Surfacing - Wet Pour		
Finding : Shrinkage/separation giving trip hazard	Low	5
Task : Re-glue and fill gaps and joints as necessary		
The overall risk for this item at the time of inspection: ‡ For Risk Score see Report Notes	Low	6

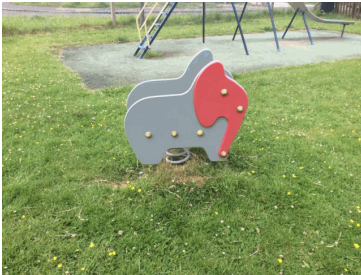
Rocker - Elephant

Risk Level : Very Low

Risk Score : 3

Comments, action or control required	Risk Level	Risk Score ‡
Equipment No remedial maintenance work is required at this time.		
Surfacing - Grass No remedial maintenance work is required at this time.		
The overall risk for this item at the time of inspection: ‡ For Risk Score see Report Notes	Very Low	3

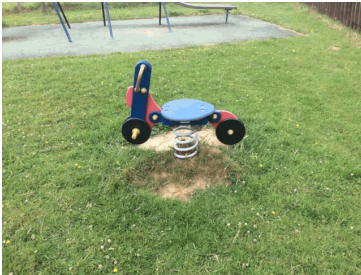
Rocker - Motorbike

Risk Level : Very Low

Risk Score : 3

The item fails to meet the requirement of the relevant standard.

Comments, action or control required	Risk Level	Risk Score ‡
Equipment		
Finding : Protruding handles/footrests		
Task : Monitor		
Surfacing - Grass No remedial maintenance work is required at this time.		
The overall risk for this item at the time of inspection: ‡ For Risk Score see Report Notes	Very Low	3

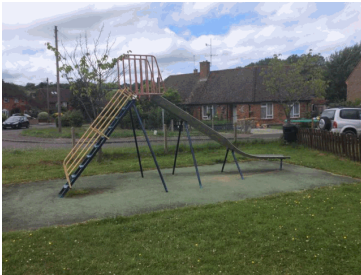
Slide

Risk Level : Low

Risk Score : 5

The item fails to meet the requirement of the relevant standard.

Comments, action or control required	Risk Level	Risk Score ‡
Equipment		
Finding : The spacing between the barrier bars is in excess of 89 mm	Low	6
Task : Monitor and check on a routine basis		
Finding : There is a toggle entrapment	Low	6
Task : Remove toggle entrapment		
Finding : Access fails entrapment requirements	Low	6
Task : Monitor and check on a routine basis		
Finding : Item - Corrosion	Medium	
Task : Repair item		
Surfacing - Wet Pour No remedial maintenance work is required at this time.		
The overall risk for this item at the time of inspection: ‡ For Risk Score see Report Notes	Medium	6

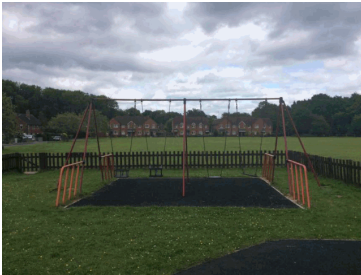
Swing - Mixed - 2 Bay 4 Seat

Risk Level : Low
Risk Score : 7

Comments, action or control required		Risk Level	Risk Score ‡
Equipment			
Finding : Loose swing seat eye-bolts Finding Date : 17/06/2015	 	Low	5
Task : Tighten connecting nuts Finding : Item - Damaged Finding Date : 17/06/2015 Notes : End cradle seat is bent.	 	Low	7
Task : Replace item Finding : Item - Limited Life		Medium	12
Task : Programme replacement

Finding :	There is considerable wear to the swing-chains.	Medium	12
Task :	Replace worn parts		
Finding :	The swing seat has been damaged but does not require immediate replacement	Low	6
Task :	Monitor and replace when hard material is exposed		
Finding :	Some chain wear	Medium	8
Task :	Monitor for further deterioration and replace at 40% wear		
Surfacing - Wet Pour		No remedial maintenance work is required at this time.	
The overall risk for this item at the time of inspection: ‡ For Risk Score see Report Notes		Medium	12
